**SITE ASSESSMENT REPORT  
WILSON SHIRT FACTORY REMOVAL ASSESSMENT  
SOUTH BEND, INDIANA**

**U.S. ENVIRONMENTAL PROTECTION AGENCY  
Region 5  
Chicago, Illinois 60604**

<b>TDD NO.:</b>	S05-0001-1903-300	
<b>EPA OSC:</b>	Thomas Mendez	
<b>SITE NAME:</b>	Wilson Shirt Factory – RS	
<b>SITE LOCATION:</b>	South Bend, St. Joseph County, Indiana	
<b>REPORT PREPARER:</b>	Brendan Martin	
<b>SIGNATURE/DATE</b>

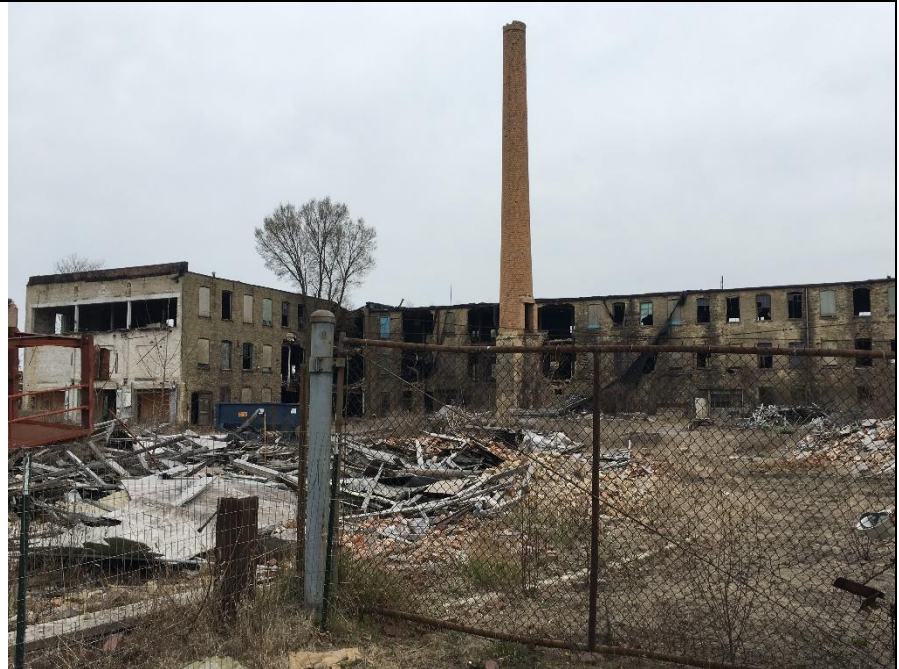
### Photograph No. 1

**Description:** Site overview photo from southern perimeter facing north. Photo includes site entrance, smoke stack, debris piles, and remaining west and north structures.

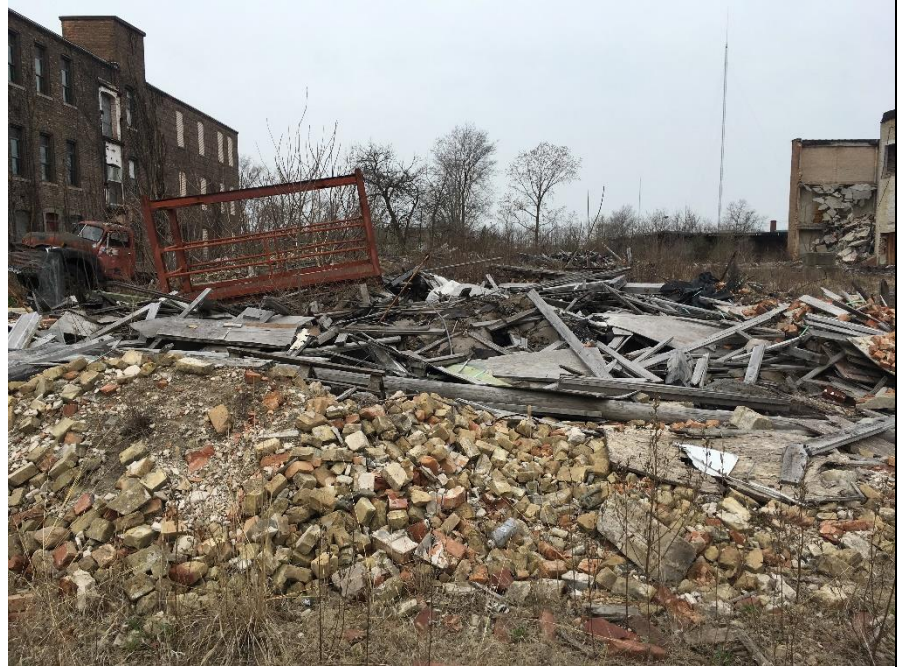
### Photograph No. 2

**Description:** Site overview photo from southeastern area facing west. Photo includes debris piles on southern portion of site. The structure of the left-hand side of the photo is the neighboring property, Werntz Supply.

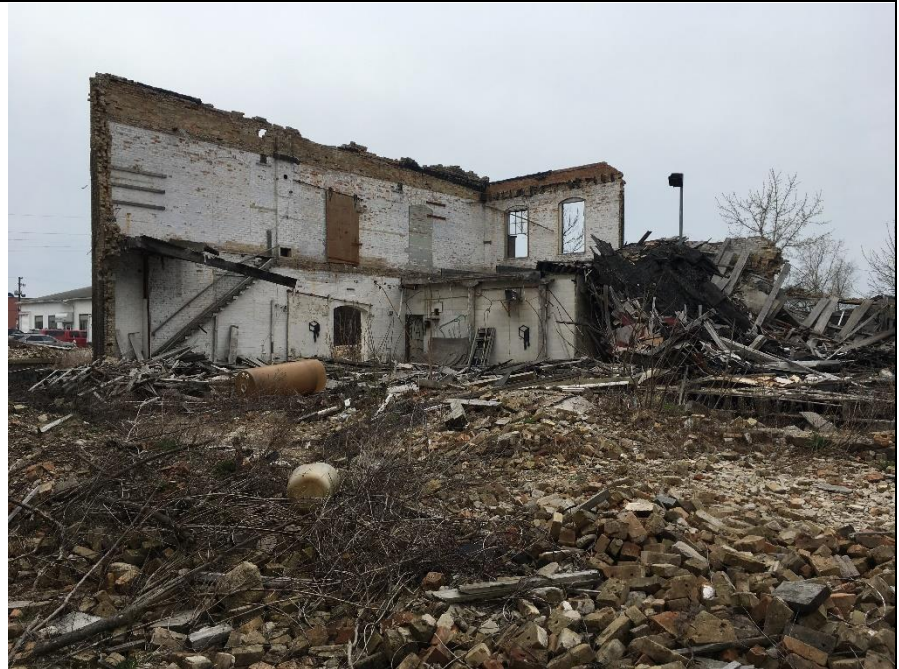
### Photograph No. 3

**Description:** Site overview photo from eastern perimeter facing southwest. Photo includes remnant walls and debris piles from demolished eastern structure.

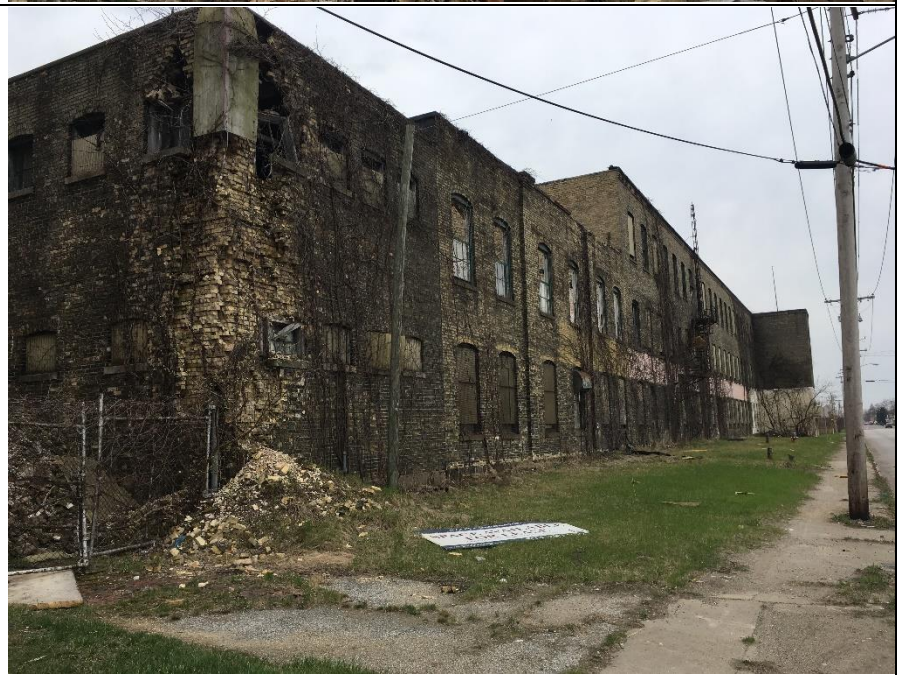
### Photograph No. 4

**Description:** Site overview photo from northeastern perimeter facing west. Photo includes northern structure and West Sample Street (northern site perimeter).

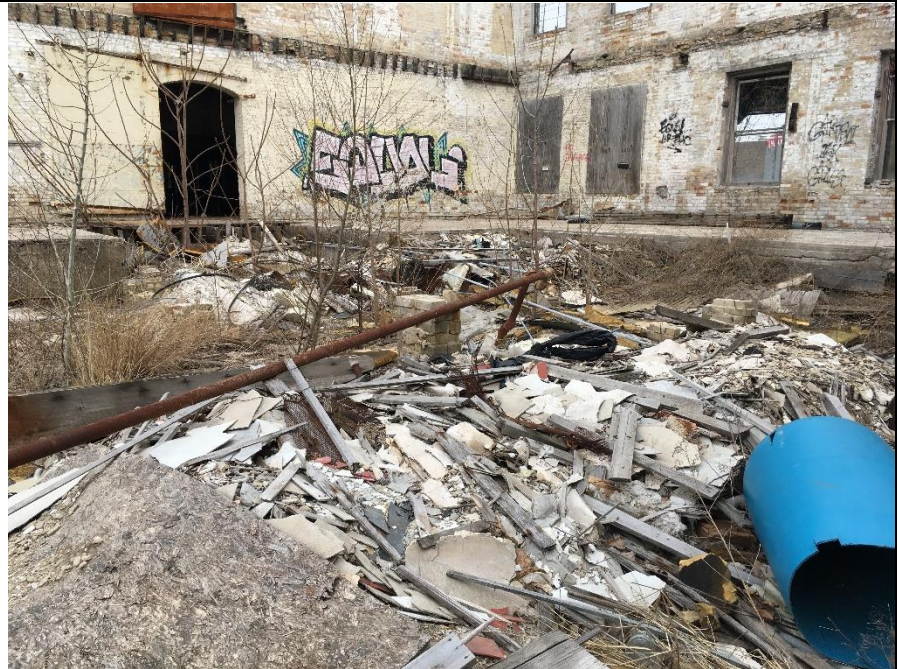
### Photograph No. 5

**Description:** Evidence of trespassing on-site, graffiti on exterior of northern structure.

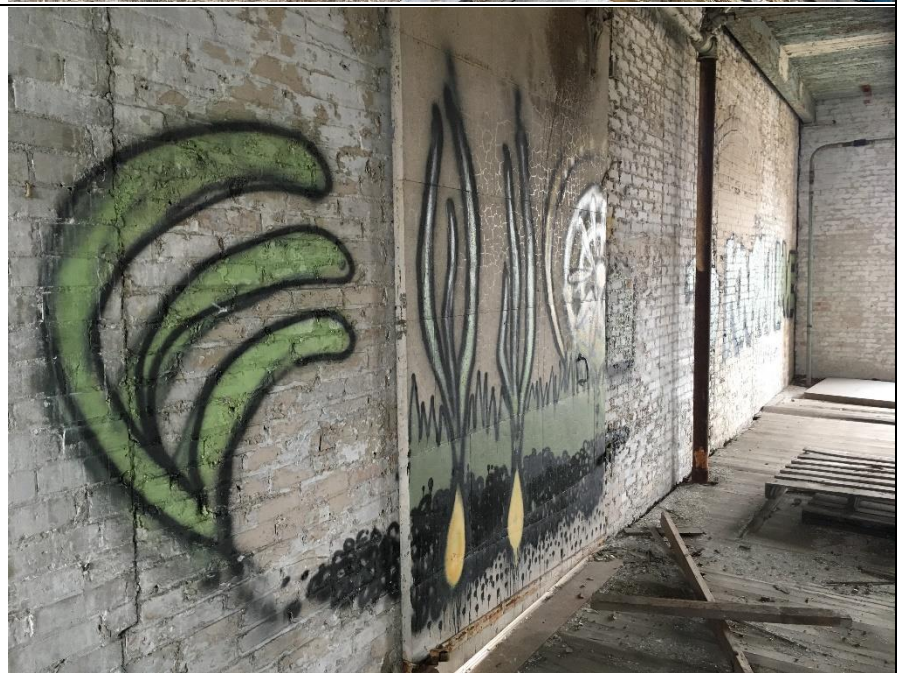
### Photograph No. 6

**Description:** Evidence of trespassing on-site, graffiti on interior of north structure.

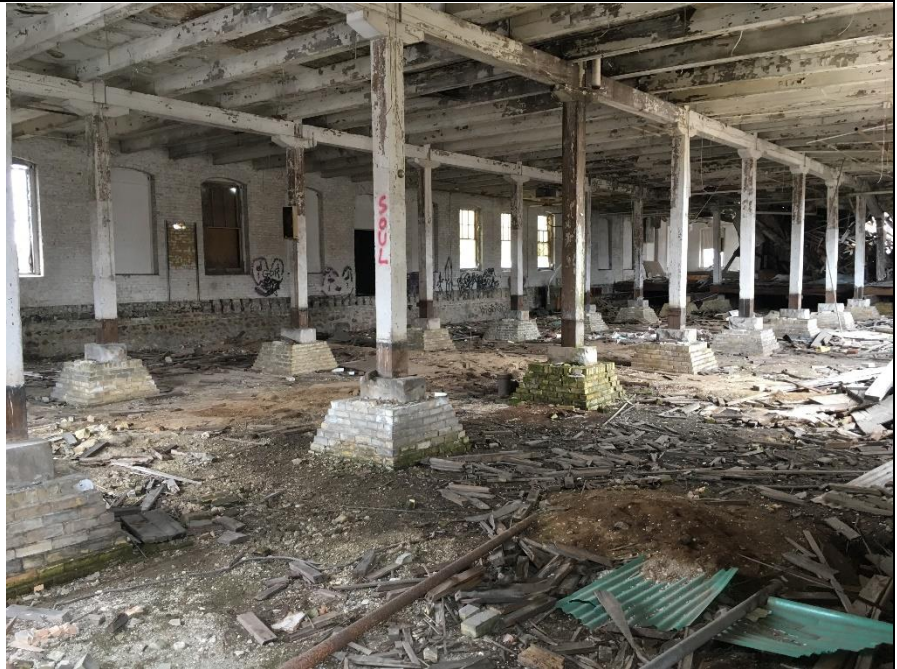
### Photograph No. 7

**Description:** Evidence of trespassing on-site, graffiti on interior of west structure.

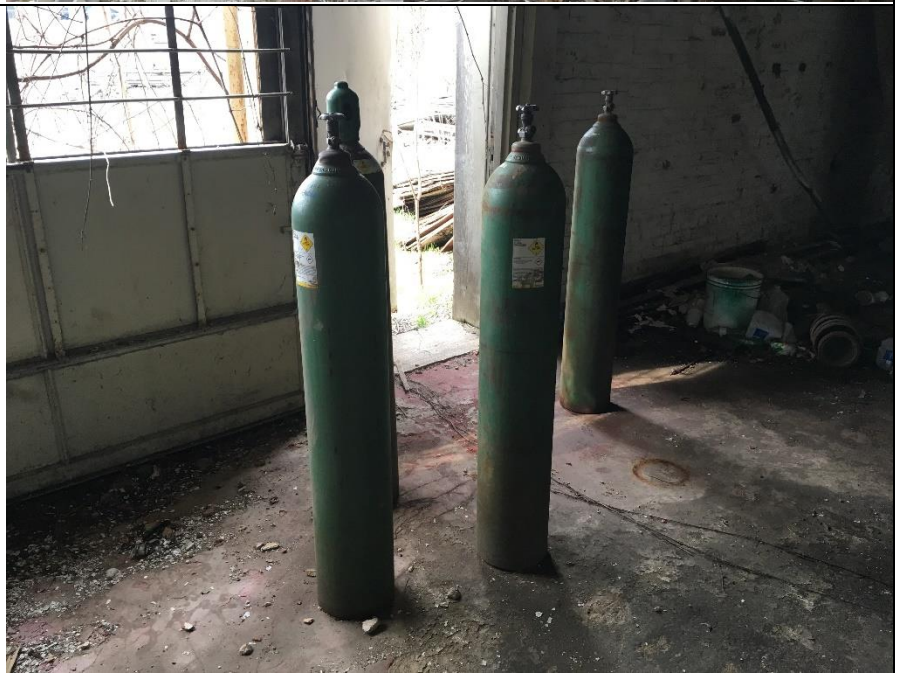
### Photograph No. 8

**Description:** Site hazard, four compressed oxygen gas cylinders located in northern structure. Oxygen volume unknown.

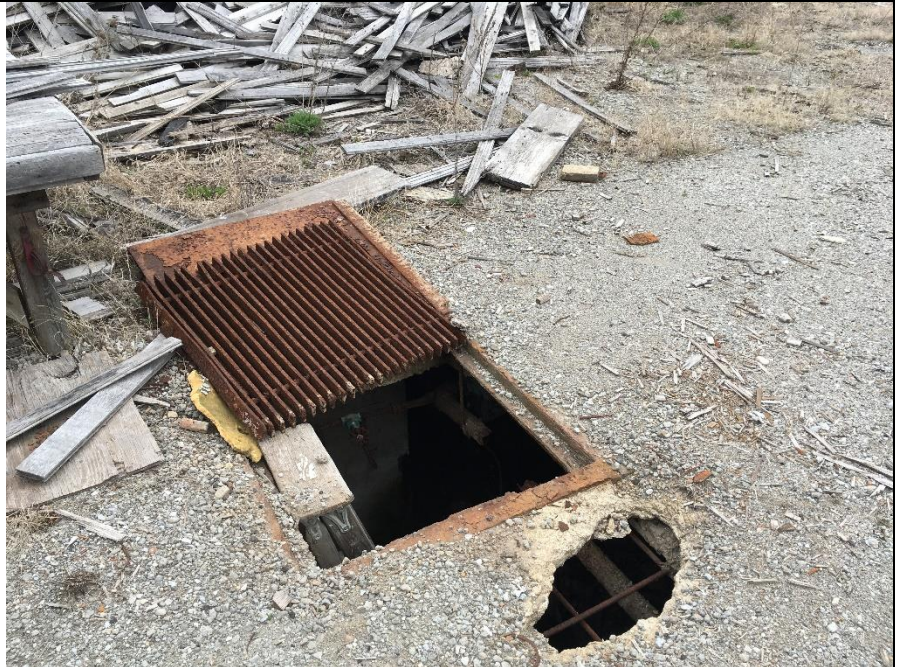
### Photograph No. 9

**Description:** Site hazard, underground area with failing roof, located near stack in central area of site.

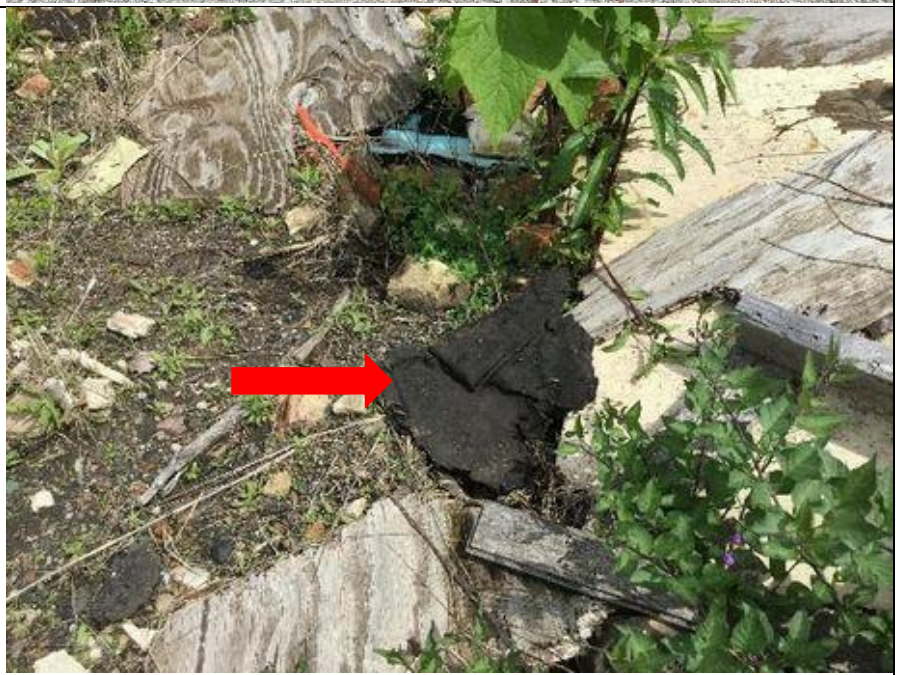
### Photograph No. 10

**Description:** Bulk asbestos samples WSF-B01-20190529 and WSF-B08-20190529. Black roofing material, tar with paper backing, located in debris pile in southeast area of site.

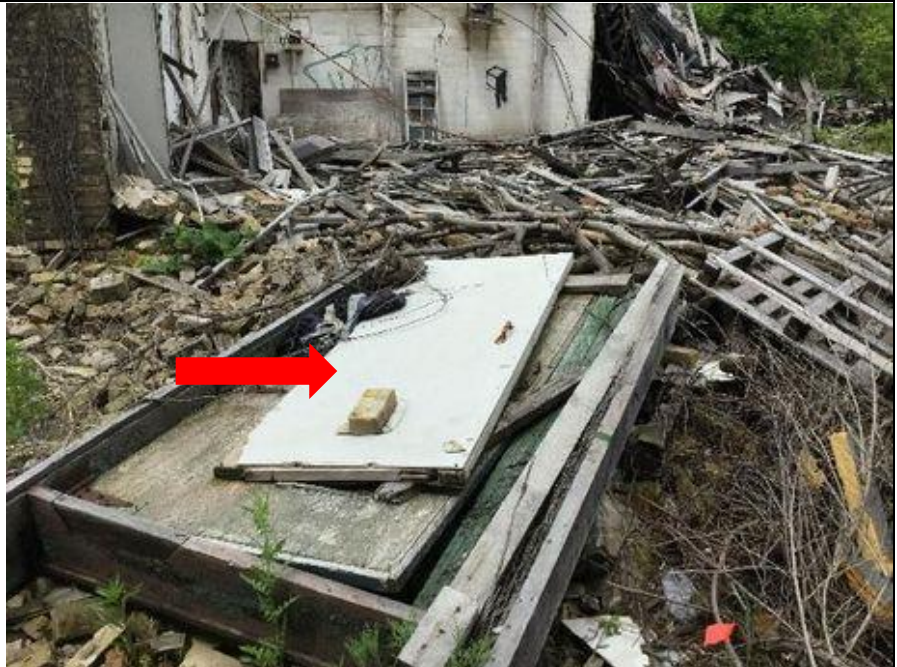
### Photograph No. 11

MATERIAL DESCRIPTION	ASBESTOS PERCENTAGE AND TYPE
Transite Fire Door	20 to 25 percent chrysotile
Transite Siding	15 to 20 percent chrysotile
Floor Tile and Associated Mastic	3 to 8 percent chrysotile

A visual inspection of the bulk materials identified as ACM indicated that those materials had been rendered to a friable state during building demolition and as a result of weathering during exposure to the elements. A friable asbestos material contains more than 1 percent asbestos that, when dry, can be crumbled, pulverized, or reduced to powder by hand pressure, such as spray-applied fireproofing on structural steel members, spray-applied acoustical ceiling materials, or damaged thermal system insulation; these are considered Regulated Asbestos Containing Materials (RACM). Removal and disposal of RACM by an Asbestos Hazard Emergency Response Act (AHERA) certified asbestos inspector is necessary. Because the identified ACM is considered RACM, and is mixed throughout the demolition debris, the demolition debris is considered asbestos-contaminated material, and removal and disposal of it according to Federal EPA guidelines is required.

**Description:** Bulk asbestos samples WSF-B02-20190529 and WSF-B09-20190529. Grey transite fire door located in debris pile on eastern side of site.

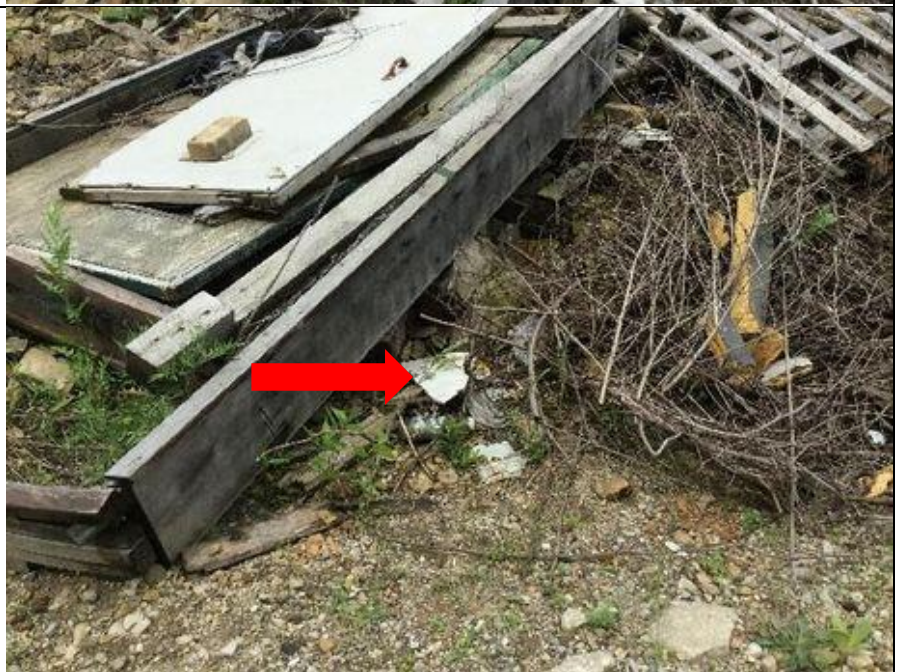
### Photograph No. 12

**Description:** Bulk asbestos samples WSF-B03-20190529 and WSF-B10-20190529. Grey and white transite siding located in debris pile on eastern side of site.

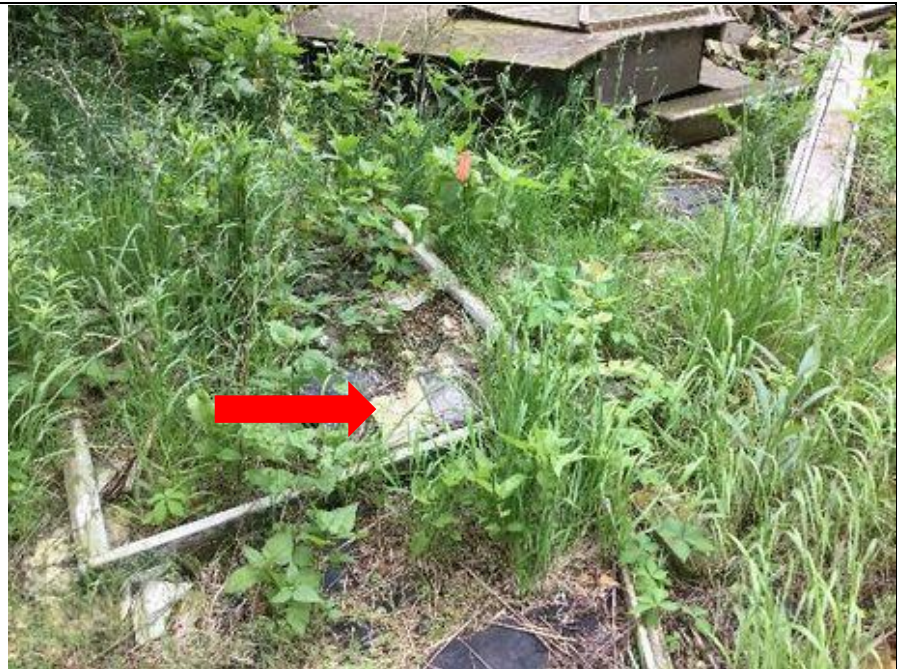
### Photograph No. 13

**Description:** Bulk asbestos samples WSF-B04-20190529 and WSF-B14-20190529. Grey and green transite siding located in debris pile on northeastern corner of site.

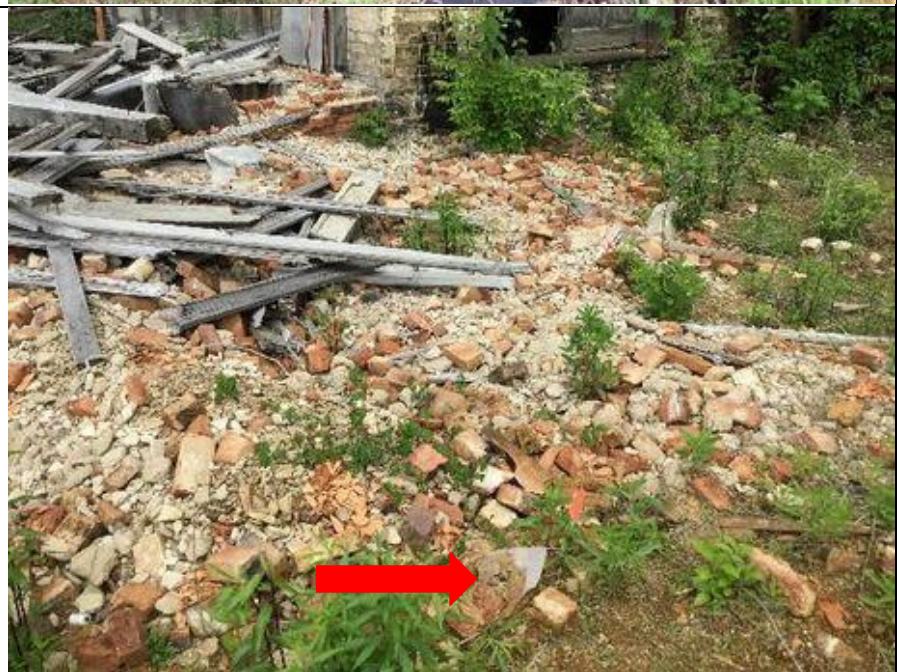
### Photograph No. 14

**Description:** Bulk asbestos samples WSF-B05-20190529 and WSF-B12-20190529. Red sheet flooring located near southeastern corner of west structure.

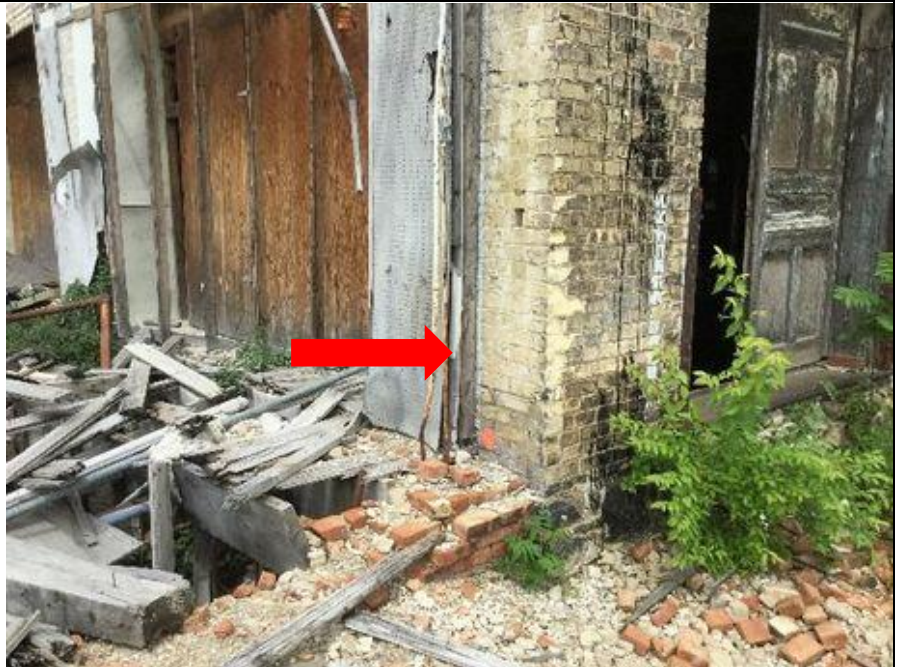
### Photograph No. 15

**Description:** Bulk asbestos samples WSF-B06-20190529 and WSF-B11-20190529. White drywall located on southeast corner of west structure.

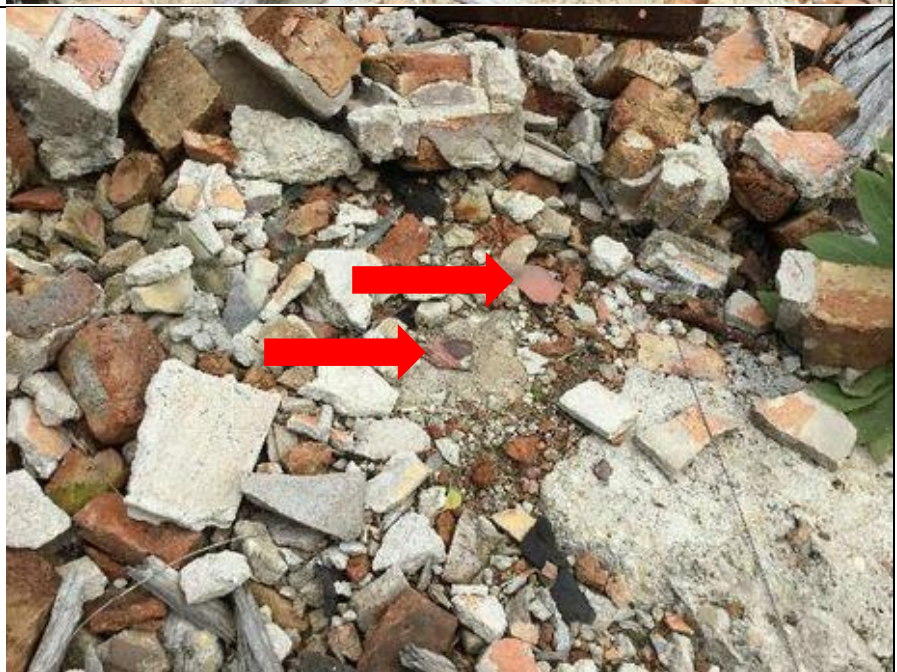
### Photograph No. 16

**Description:** Bulk asbestos samples WSF-B07-20190529, WSF-B13-20190529, and WSF-B15-20190529. Red floor tile and black mastic located on debris pile directly south of western structure.

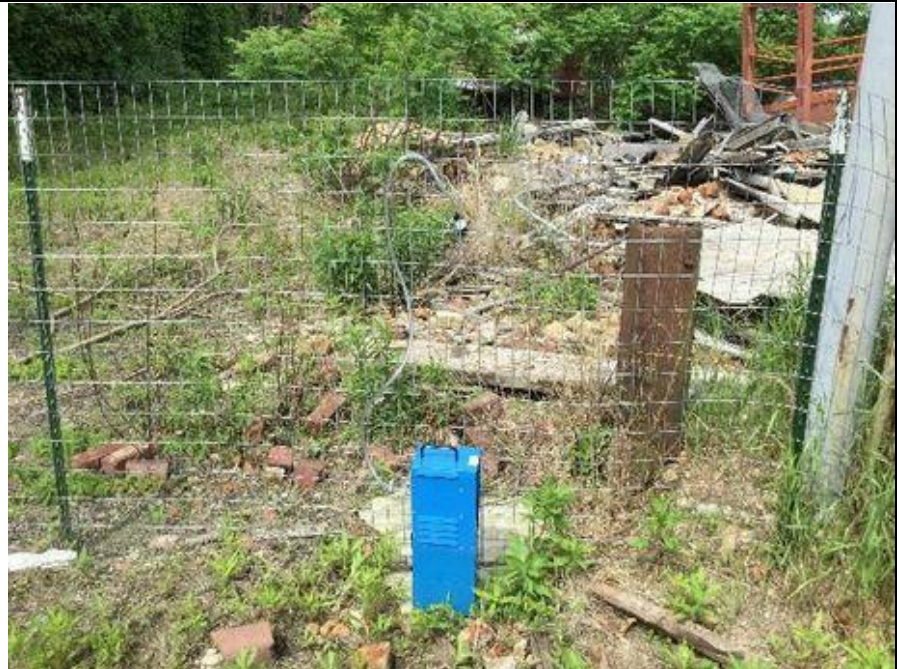
### Photograph No. 17

- WSF-S01-20190529 was an ambient air sample collected at the south perimeter air station and found to contain 0.003 fibers/cc.

**Description:** Southern perimeter high-flow air station, asbestos air sample WSF-S01-190529. Sample collected using an AirCon2 pump.

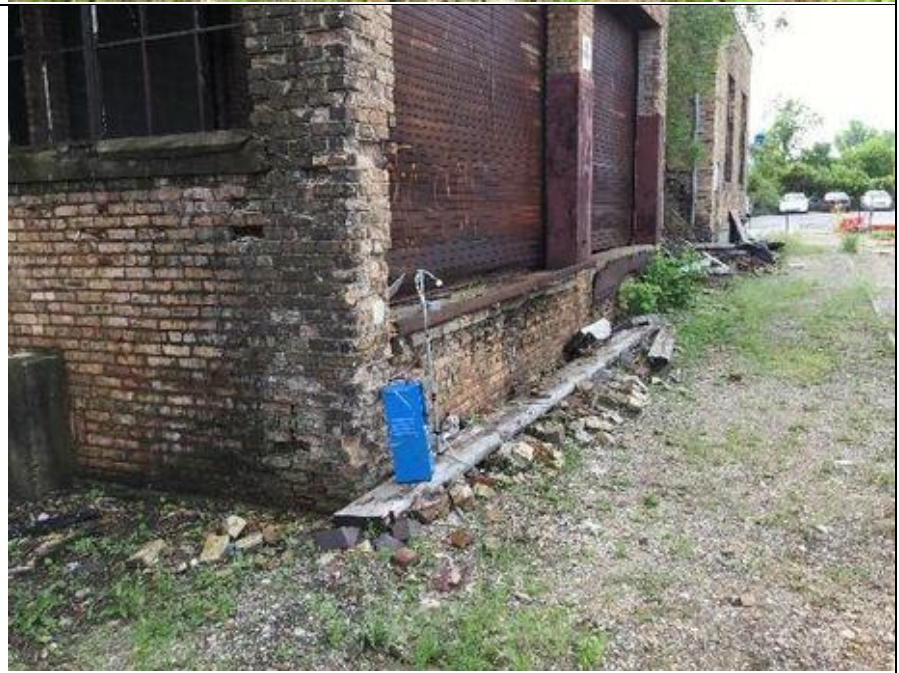
### Photograph No. 18

**Description:** Eastern perimeter high-flow air station, asbestos air sample WSF-S02-190529. Sample collected using an AirCon2 pump.

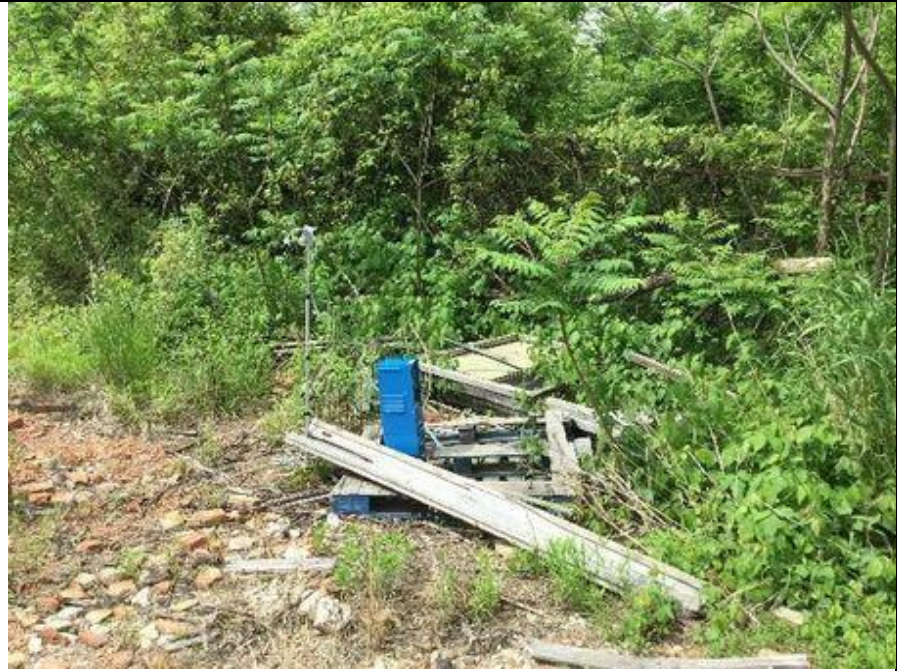
### Photograph No. 19

- WSF-S03-20190529 was an ambient air sample collected at the west perimeter air station and found to contain 0.003 fibers/cc.

**Description:** Western perimeter high-flow air station, asbestos air sample WSF-S03-190529. Sample collected using an AirCon2 pump.
